Transport
Canada

TP 6980E

Issue 1/2004

Canadian Aviation Service Difficulty Reports

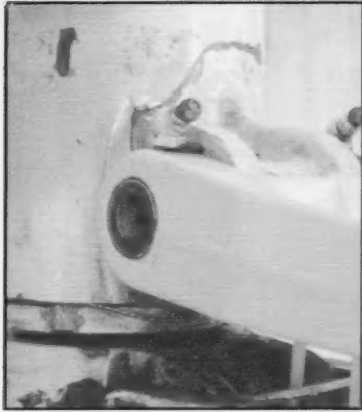
SDR # 20030317008

Landing Gear Upper Brace Assembly Cracked

After a pilot reported the R/H main gear oleo was low, maintenance attempted to inflate the oleo with nitrogen. The nitrogen immediately started to leak from a large crack around the upper torque knee boss on the brace assembly, P/N 50-8103327. The crack was approximately six inches in length starting at the bottom of the brace assembly, going up the radius on the left side of the boss and turning, crossing over the top of the boss. The submitter also added that this gear had 277 cycles since inspection.

The submitter has determined that this was not the result of a hard landing. They suspect that stress in the radius area caused the crack. This particular upper brace assembly, P/N 50-8103327, was only installed on the aircraft with serial numbers 1 through 161. Raytheon has two other upper brace models in service (P/N 50-810332-3 & 99-810028-7) that are employed on the later King Air models. The submitter also added that these upper braces are machined differently in the area that the crack was discovered.

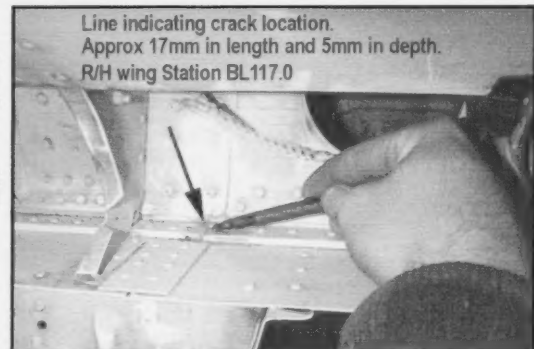
Spar Cap Cracked

A crack was found in the R/H lower spar cap, P/N 1181200291, horizontal flange at Station BL117.0. The crack extended from the rivet hole aft to the edge of the flange and forward, just shy of the flange radius (of the vertical leg).

Part Time Since New (TSN): 16961 hours

Part Cycles: 25489

Maintenance personnel noticed the crack on a pre-flight inspection. The manufacturer was contacted and an approved repair was initiated to splice in a new piece of the lower cap.

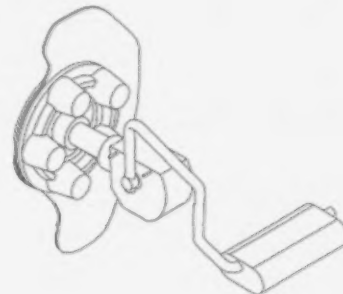
Upon compliance of the fuel quantity indicators performance test (annual item), it was noted that the L/H wing fuel level sending unit transmitter, P/N 53331 1, did not go to zero (indicated slightly above the '0' reading on the gauge).

Further inspection revealed that the transmitter arm was resting on a stringer inside the tank. It was determined that the transmitter installed in the L/H wing was the part number for the R/H wing. The correct sending unit was installed and the system functions normally.

This aircraft was delivered from the factory with this installation.

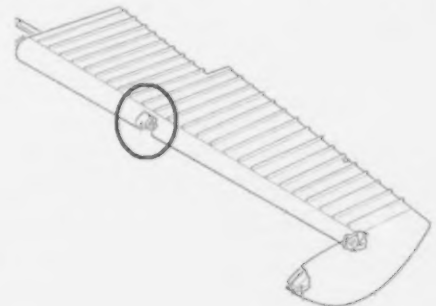
Elevator Center Hinge Attach Point Cracked

The L/H elevator front spar, P/N C2-TE-37ND, upper attach hole for centre hinge had a small radial crack around the upper AN3 bolthole.

Transport Canada has received three similar reports of cracking at the elevator front spar center hinge attach point. The defects were discovered during inspection.

The cracking is occurring radially around the attachment bolthole.

To ensure similar defects are detected, Transport Canada recommends operators of this aircraft model; pay close attention to this area during inspection or whenever maintenance allows access.

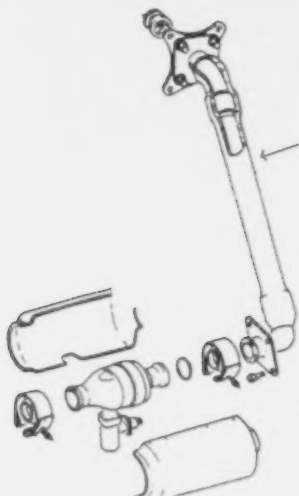
SDR #20031008005

**Nacelle Bleed Air Line Ruptured**

The pilots had the beta backup system on the R/H engine fail in flight. It was discovered by the engineer that the bleed air line, P/N C6VW10263, had ruptured in the braided area where it leaves the engine compartment and goes into the wing.

The wire bundle sustained damage by the bleed air, which resulted in the harness shorting out causing the beta light failure. The line was original and was corroded from the inside out.

Removal and close inspection of this line during inspection may have prevented this failure.

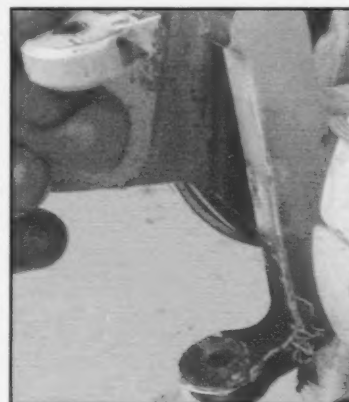
Inboard Aileron Hinge Broken

Upon return, from performing a firebombing mission, the pilot complained of flutter in the controls, however, an initial inspection revealed no damage. A further in-depth detailed inspection revealed a broken L/H wing inboard aileron hinge.

Due to the condition of the hinge, it was determined to have happened some time before, and because it could not be determined when the failure occurred, both hinges were replaced due to potential stress the breakage applied on the undamaged hinge.

The aileron hinges were Non-Destructive Tested at 315.9 hours previously, during the aircraft's airframe extension program.

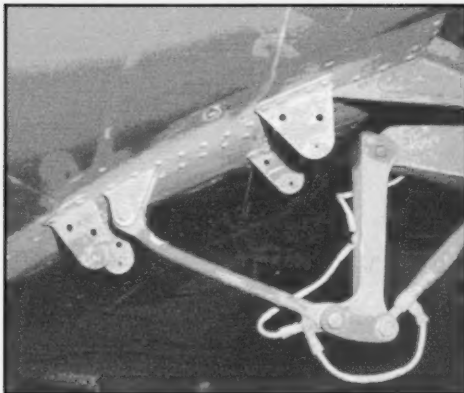
SDR # 20031208006

**Flap Fairing Bent**

An operator was performing a 100-hour inspection and found the L/H wing flap aft link, P/N 527.52.12.133, bent at the center flap position.

The flap fairings were removed and all linkages were inspected. No faults were found on the R/H flap that was inspected.

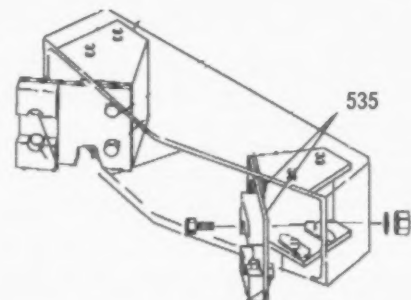
Investigation revealed the L/H rudder stop pad attaching bolt, P/N NAS6203, became loose and broke. The area was inspected and the bolt replaced.

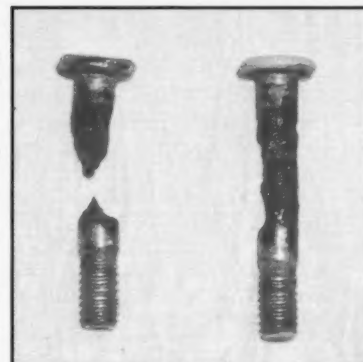
Engine Mount Pin Corroded

During a special inspection of engine mount legs introduced on an operator's Bell 206L/L1 aircraft, the lower pins, P/N 100-048-5-12, were found severely corroded. One of the pins was severed.

A varying degree of corrosion was also observed on the inner diameter of the engine mount legs. Some legs were rejected upon preliminary inspection.

The operator has introduced a mandatory 3-year corrosion inspection of the Bell 206L engine mount legs requiring removal of pins and disassembly of legs.

Keep this in mind when inspecting this area. Disassembly for further inspection may be required. These engine mounts may be employed in earlier Bell 206L models. Stainless steel mounts are now incorporated in Bell 206L models.
